## 3 Tools for Troubleshooting Philips X5-1 Performance Issues

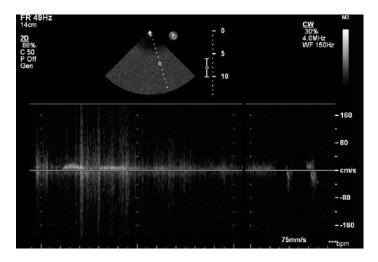
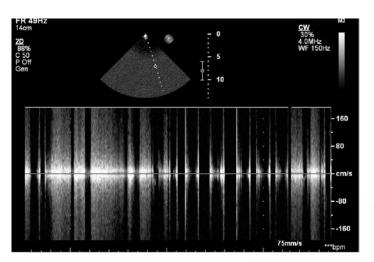
When testing factory new and slightly used probes, results will present audibly as, what sounds like, slight rubbing and visually as minor gray spikes, peaks and valleys in the spectral area. If the wires are beginning to fail (or have failed) hard/heavy static will be heard, and very pronounced white spikes will be visualized. The amount of acceptable static is highly subjective and can be interpreted differently by different people. Typically, more than one wire breaks down at a time and failures will be identified at multiple locations throughout the image. If **CONSTANT** static is encountered at some point, the point of failure may not be cable related.

The results in the left image may be considered acceptable. Those on the right are exhibiting unnacceptable levels of excessive noise or static

**Note:** The preferred method of addressing wiring failures is to *REPLACE* the wiring harness. It's the one method that results in restored, like-new, performance and longevity.

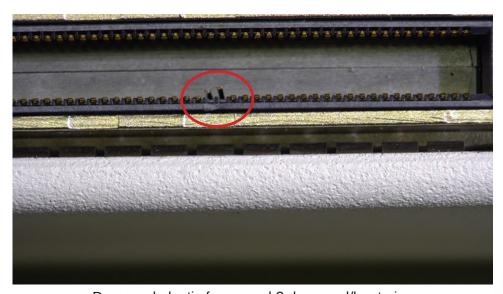
Damaged plastic frame and 2 damaged/bent pins

- 1. Begin troubleshooting by thoroughly inspecting the pin bank on the reported probe and ALL ports on ALL scanners on which the probe MAY be used. Under magnification, inspect EACH pin. Look for deformations, compressed areas, oxidation and corrosion. The Compact Extreme (CX/Epiq) style connectors can be challenging to fully visualize, so use items such as headset magnifiers and dental mirrors to assist. Defects can be easily missed. It's also possible that a single bent pin on a single probe has compromised the connectors across multiple ports on multiple scanners. The damage to one port, then affects the next probe connected. So on and so forth.

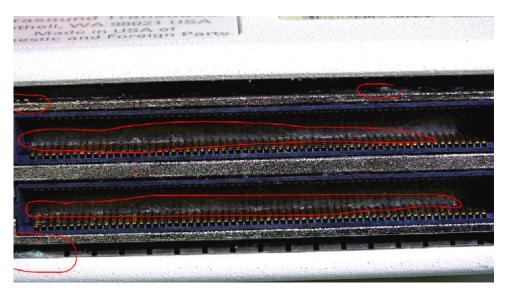
Corrosion, oxidation and dust can affect the quality of connection between the probe and the scanner. Thoroughly inspect the pin bank within the connector as well as ALL ports on the scanner.
