Achieving Excellence Ultrasound Probe Performance

Standard Probe Visual Inspection Guide

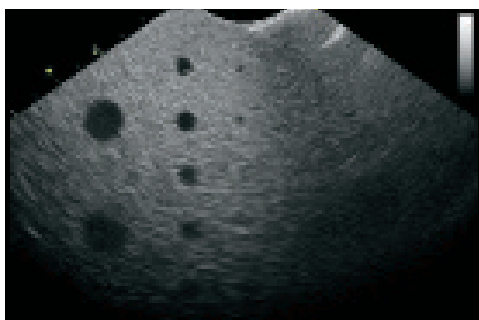
Image Shadowing

A tissue-mimicking phantom should always be used to verify image quality.

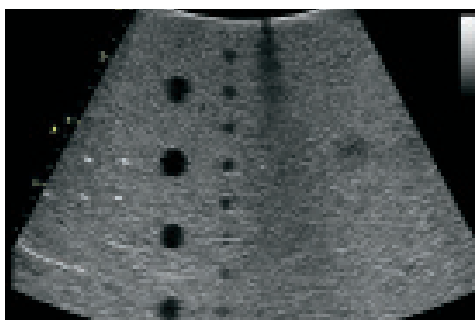
Image Dropout

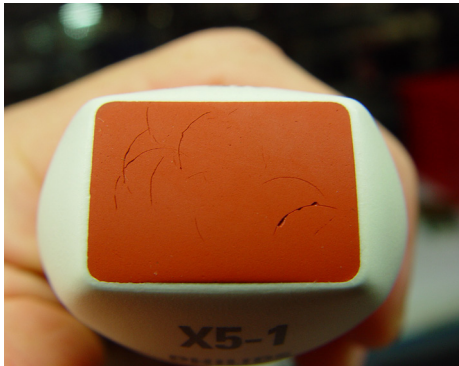
Damaged Acoustic Lens

- Punctures/Perforations
Delaying attention to minor deficiencies in the acoustic lens could lead to more costly repairs at a later date.
- Delamination
Air and/or other materials can become trapped between the acoustic array and the lens causing degradation of image quality.

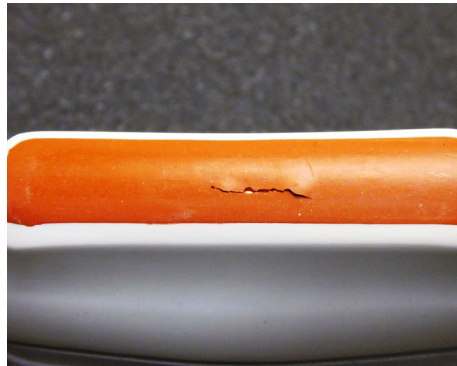
Worn Acoustic Lens

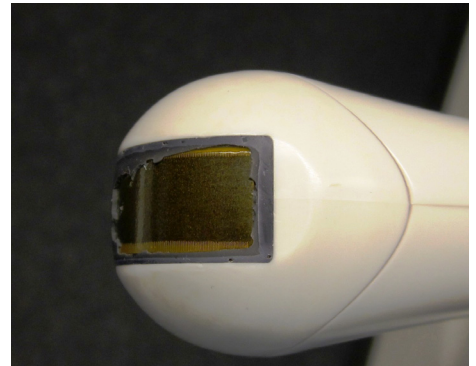
Missing Acoustic Lens

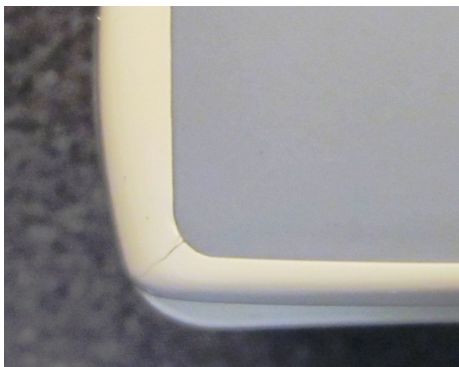
Cracked Probe Housing

- Cracks or Worn/Open Seams
May permit entry of cleaning fluids leading to catastrophic electro-mechanical failures.

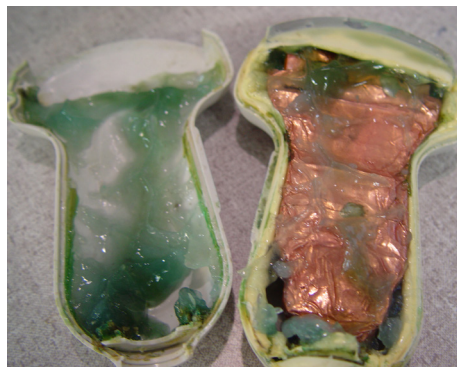
Gel Intrusion/Cross Contamination

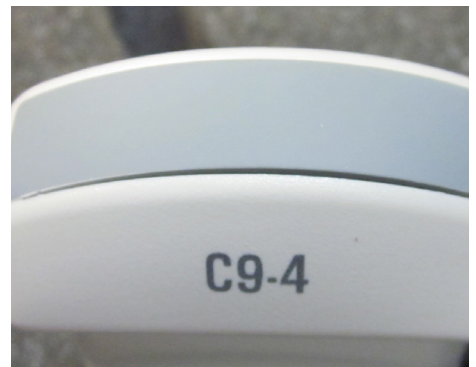
Open Seams on Probe Housing

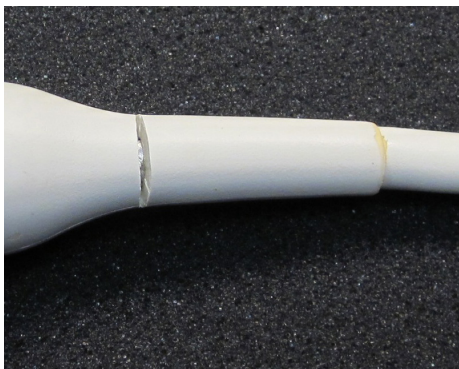
Damaged Strain Relief

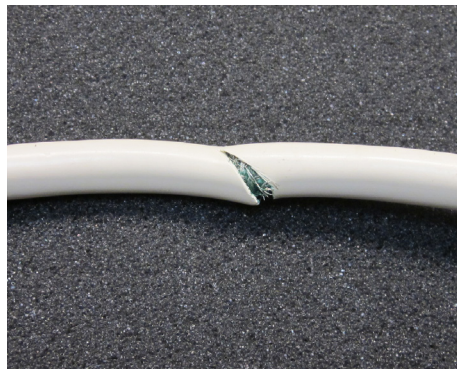
Cut Cable

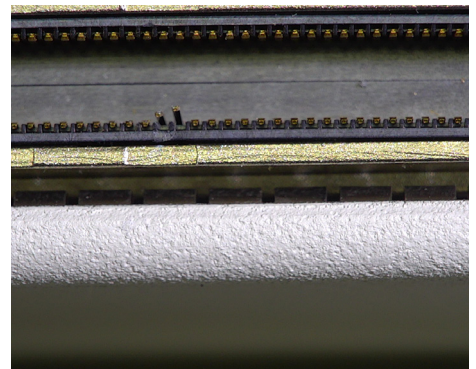
Damaged Pin Bank
