## 3 Tools for Troubleshooting Philips X5-1 Performance Issues

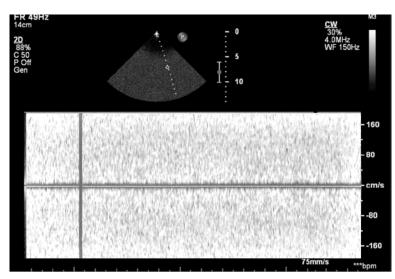
Another very common mode of failure with this probe model is constant static in CW (continuous wave) Doppler mode at only specific locations within the image. The problem may or may not actually be repeatable, which makes it extremely frustrating for echo-techs as well as service personnel. A strong percentage of the X5-1's exhibiting this phenomenon may actually have no problem whatsoever, however; it is likely that it is THE most frequent reason for which the probe is replaced.
