# Three Ways to Prevent Catastrophic TEE Failures

## Transesophageal (TEE) Probe Visual Inspection Guide

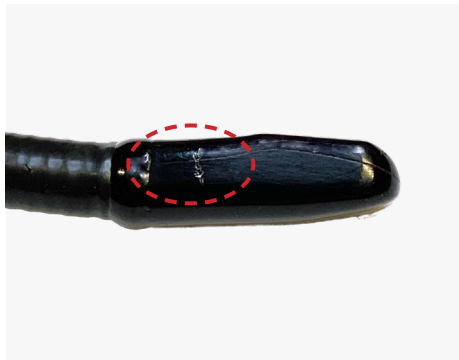
**Cracked Distal Tip**

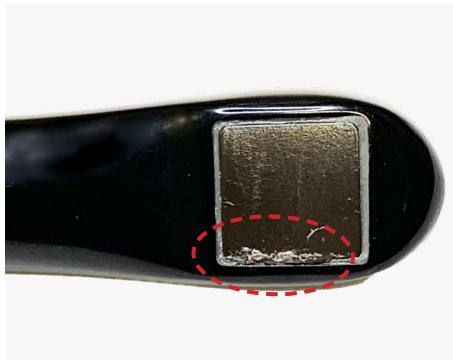
**Damaged Lens**

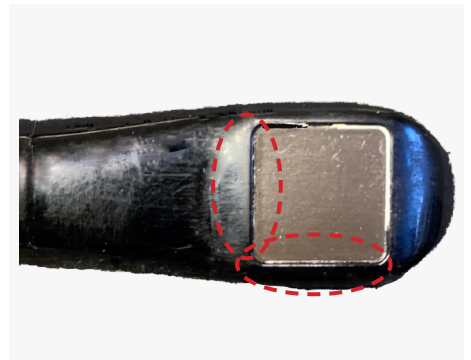
**Missing Lens Seals**

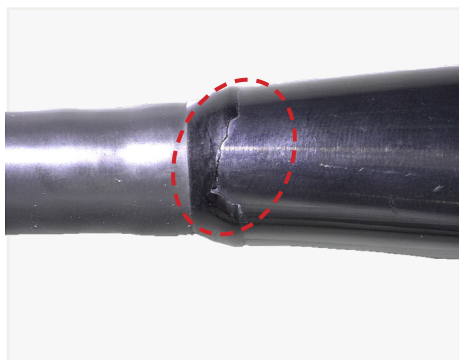
**Damaged Glue Bead**

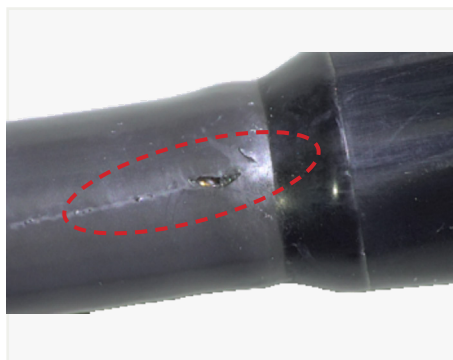
**Punctured Bending Rubber**

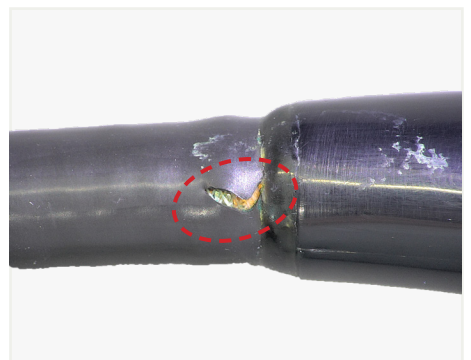
**Cut/Torn Bending Rubber**

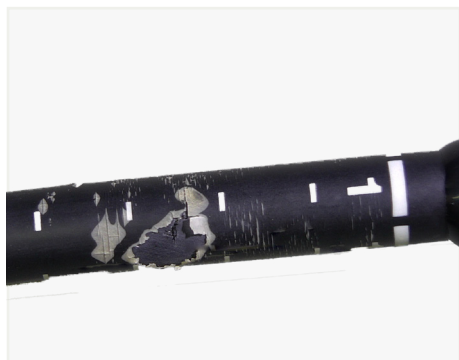
**Cut/Damaged Insertion Tube**

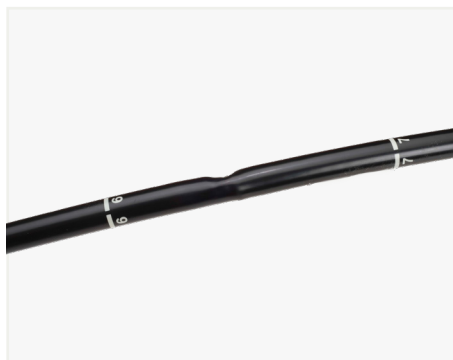
**Crushed Insertion Tube**

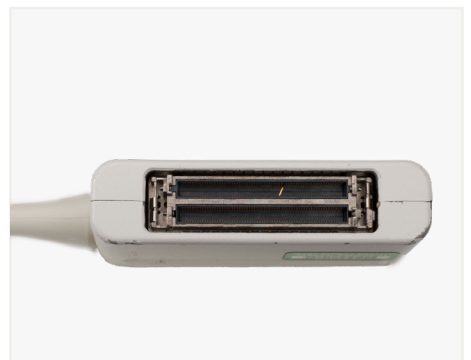
**Bent/Damaged Connector Pins**
